**SUNNY SHORES DAM
JACKSON COUNTY, MISSOURI
MO 20237**

PHASE 1 INSPECTION REPORT NATIONAL DAM SAFETY PROGRAM

Name of Dam	Sunny Shores Lake Dam
State Located	Missouri
County Located	Jackson County
Stream	Tributary to Little Blue River
Date of Inspection	12 September 1978

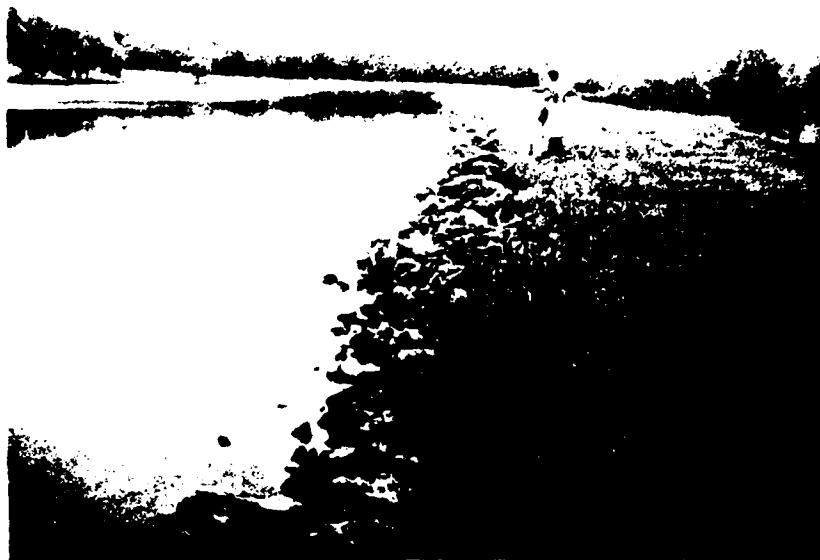
PHOTO 1: UPSTREAM FACE (LOOKING EAST)

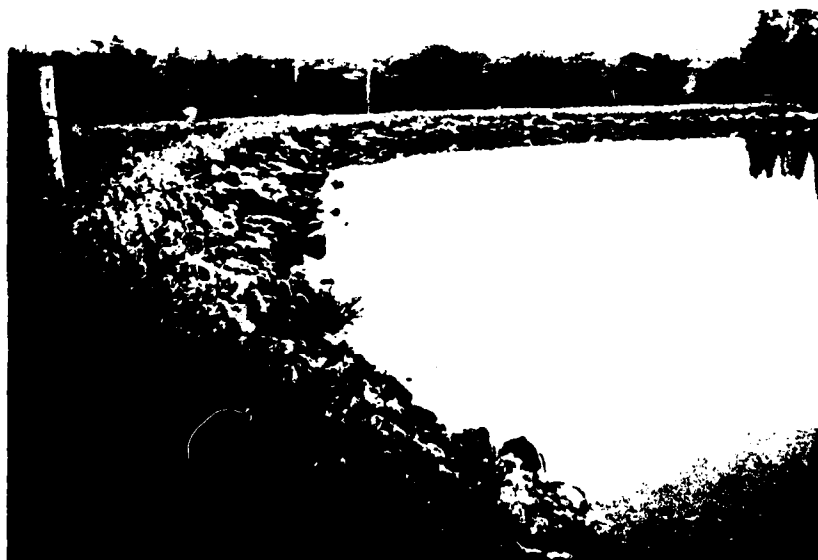
PHOTO 2: UPSTREAM FACE (LOOKING SOUTH)
